BUILDING DAMAGE AND HUMAN CASUALTIES DURING THE BAM-IRAN EARTHQUAKE

Yasuko Kuwata*¹, Shiro Takada¹ and Morteza Bastami²

¹Department of Architecture and Civil Engineering, Kobe University

Keywords: Bam earthquake, adobe masonry structure, human casualties, DEM

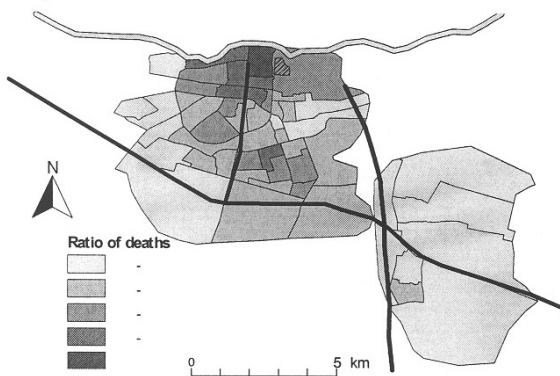
Figure 4. Ratio of deaths

The distributions of ratios of building damage, deaths and injured people in the 52 districts of Bam and Baravat are shown from Figure 2 to Figure 5. As a whole, the building damage is concentrated in the west of Bam, which is near the hidden fault line [1]. The buildings that collapsed completely in Baravat are fewer if compared with those in Bam, in which more than half of the total buildings were completely collapsed (Figure 2). However, assessing the damage ratio of completely collapsed residential houses, more than 95% of the assessed houses turned out to be completely collapsed (Figure 3). It can be said that in Baravat the ratio of completely collapsed buildings is low because there are many non-residential houses. Considering the fact that earthquake occurred early in the morning when many residents were sleeping, more than 90% people were in the houses that collapsed completely. However, while the ratio of completely collapsed residential houses was almost the same among the districts, the impact to human differed. As shown in Figure 4, about half

of residents died in the northern Bam, near the Arg-e Bam (Bam castle in Persian) and also in the southeastern area, while in the other areas had lower ratio by about 10%. Considering that neighborhood of Arg-e Bam is an old town and the south part of Bam is a new town, the high density of damage in the north can be attributed to the old buildings there. On the other hand, comparing the ratios of death and injures, northern and southeastern areas that had high death toll ratio also had high injured ratio, which represents about 20%, equal to half of the death ratio. In addition, the area where human casualties are low appears in the region between the northern and southeastern Bam. During the field survey, the authors had an occasion to inspect the damaged area by helicopter. Few buildings seemed to be collapsed from the sky, and buildings in these areas had flat roofs; few of the adobe masonry structures had a particular arch form. The difference between the complete collapse of adobe masonry structure and other masonry structures may have influenced in the death toll and the injured people.

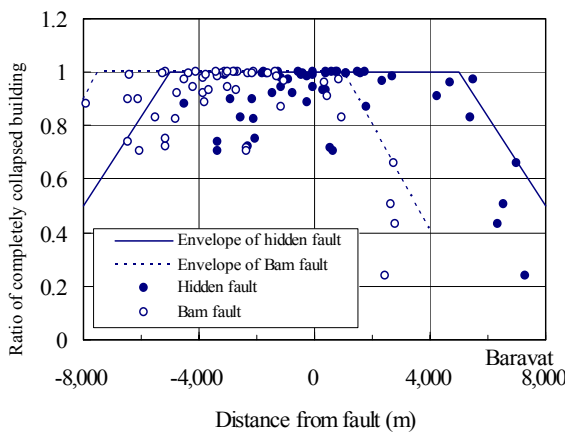
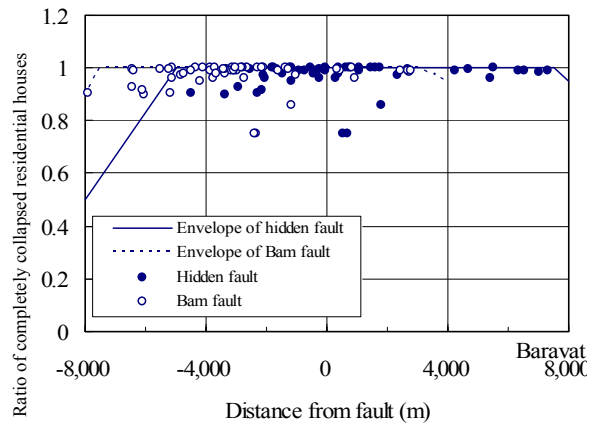
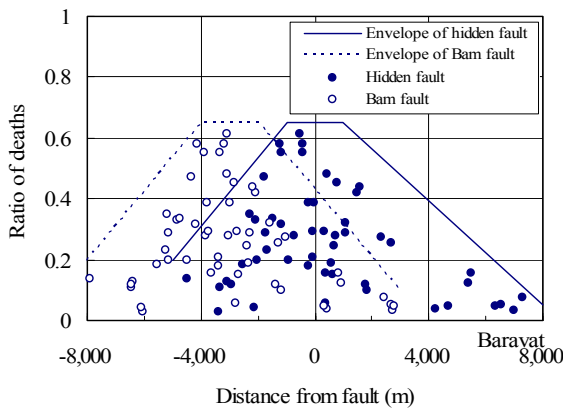
Figure 6 to Figure 9 show the distribution of damage ratios in each district related to the distance from fault lines. The plus direction of distance axis means the distance on the east side, Baravat, and the minus one on the west side. Here we used two fault lines; Bam fault and the hidden fault based on aftershock records [1] as shown in Figure 1. The hidden fault is considered as a straight line from south to north, omitting the short branch. With respect to the building damage, the ratios of most districts are so high as to be close to 1.0, especially for completely collapsed residential houses. When a line enveloping dots of ratio is drawn in the same Figure, the ratio distribution of completely collapsed building shows that the flat top of ratio exist in 10 km distance close to fault line and the ratio decreases as distance from the fault line increases. The hidden fault line lays in the middle of the bell-shaped distribution. In case of Bam fault, the middle of bell-shaped distribution shifts toward to the Bam. The ratios of human casualties show the distribution more clearly in Figures 8 and 9. The ratios of deaths and injured people distribute with peaks at the hidden

fault, and at 3 km west of Bam fault. From these Figures, if the damage were related to strong ground motion propagated from a fault, the hidden fault would be identified to cause the Bam earthquake. Not only from hypocenter determination of the aftershocks but also from the damage distribution, the hidden fault line is thought to reasonably exist.

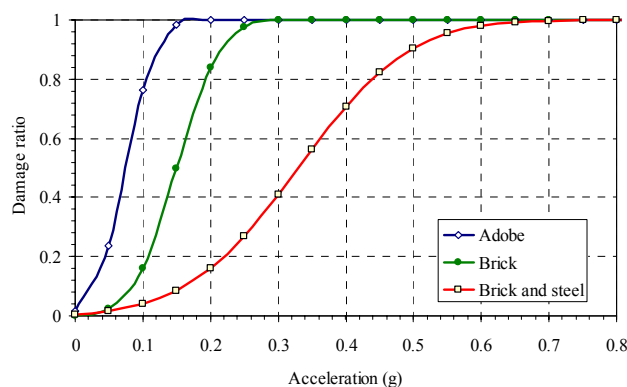
Figure 10. Fragility curves for structures

With respect to the seismic resistance of buildings, there is an Iranian code of practice for seismic resistant design of buildings [5], but it is targeted for tied-framing masonry structure and rigid-frame structures such as steel frame and RC. So, there are no legal regulations for sun-dried brick (called adobe) masonry structure that prevailed in the stricken area. Furthermore, seismic resistance of adobe masonry structures is not considered sufficiently. At the time of the Manjil earthquake of Iran in 1990, the relation between peak ground acceleration and the building damage ratio was investigated based on damage data [6]. Based on that, fragility curves for a variety of building structures in Tehran was developed regarding to the research on seismic hazard in Tehran, in a framework of an overseas JICA research project [7]. In Figure 10, the fragility curve for ‘brick and steel’ (steel frame filled with brick walls) was empirically obtained on basis of the Manjil earthquake when over 80% of the existing buildings were those masonry structures. This curve represents the fragility for brick and steel buildings; the fragility curves for other buildings were constructed by shifting the mean value of ‘brick and steel’. The peak ground accelerations observed in Bam during the earthquake were 0.7g and 0.8g horizontally and a maximum of 1.0g vertically [8]. According to the Zeraati’s report [9], 100% of adobe masonry structures, 100% of brick masonry structures without concrete frame, 90% of brick masonry structures with concrete frame, 90% of brick and steel structure were collapsed. Almost any buildings composed of masonry structures collapsed completely during the earthquake as indicated in the ratio of completely collapsed buildings shown in Figure 10, which has a value close to 100%. It can be said that the fragility curve shows a good relation with actual damage.

Two reasons can be thought about why Baravat had fewer damage. One is that the non-residential houses had ductile structures against building collapse compared with the buildings shown in Figure 10. The other is that Baravat is located at the east side of both the Bam fault and hidden fault where the ground motions were smaller. According to the acceleration records of BHRC [8], acceleration was not recorded in the area of the east side of the fault despite of being equipped with seismometers.

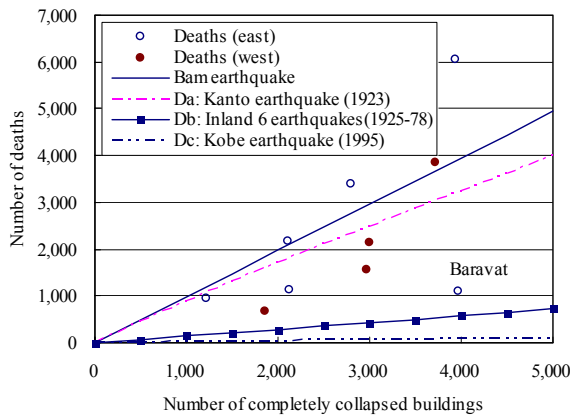
Figure 11. Relation between the number of completely collapsed number of completely buildings with number of deaths

Bam are indicated with black dots; while districts on the west side are indicated with white dots, it is possible to find a steeper relationship for the eastern area districts closer to the hidden fault which resulted in more deaths even with the same completely collapsed buildings. A regression function for the deaths D obtained by districts only in Bam is expressed with collapsed buildings H as follows.

Where, the number of buildings include all the buildings (residential houses account for 60.9%). The regression obtained herein means that one building brings about one death. The other relation between building and deaths in past Japanese earthquakes is indicated in the same Figure. D_a is the deaths obtained by Ohta et al's regression [10] by substituting parameters related to the condition of the Great Kanto earthquake in 1923. D_b is the deaths obtained by Miyano's regression [11] from inland earthquakes such as Kitatajima, Kitatango, Kitaizu, Mikawa, Fukui and Izu Oshima earthquakes. D_c is the deaths obtained by regression from Kobe earthquake in 1995, Ref. [11]. These regressions are expressed as follows:

Equation (2) shows the relation in the year of 1923, equation (3) between years of 1925 and 1978, and equation (4) in the 1995 Kobe earthquake. As the building design has been improved in Japan, coefficients of above equations decrease as the year of earthquake increases. The death toll of Bam outnumbered that of the Great Kanto earthquake, and was six times that of the six inland earthquakes, and 50 times more than the Kobe earthquake. Here, the toll of the Great Kanto earthquake is assumed as the severest case such as large-scale fire due to earthquakes, in which all the conditional coefficients C_i ($i=1,3$) of equation (2) become 1.0, and it is special case including the burned tolls. However, for the death toll only due to collapsed houses, the number in the Bam earthquake was still more than the estimated by the regression equations for earthquake damage in Japan, even by doubling the results of this estimation. The enormous death toll of Bam earthquake appears to be influenced fundamentally by structural type of masonry structures, which is completely different from Japanese wooden houses.

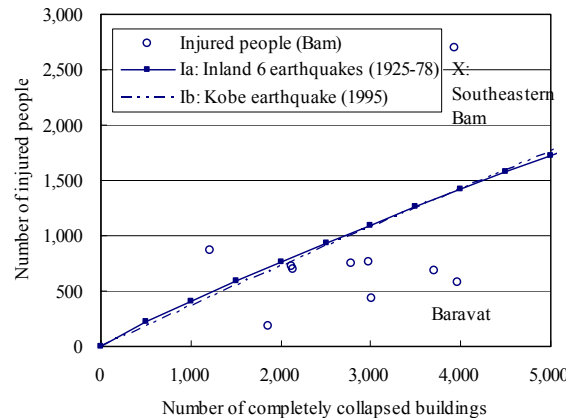
Figure 12. Relation between the collapsed buildings with the number of injured people

Although there is dispersion of half or twice in the number of injured persons in Bam regarding to the regression line, there is a tendency that the number of injured people in Bam distributes near the regression line similarly to the cases of Japan's earthquakes such as Kobe or previous ones. In the other word, damage statistics have showed that residences in Bam were overwhelmingly vulnerable to the ground motions of this earthquake. Comparing with building damage, the deaths are more than 6 times of those in the six inland

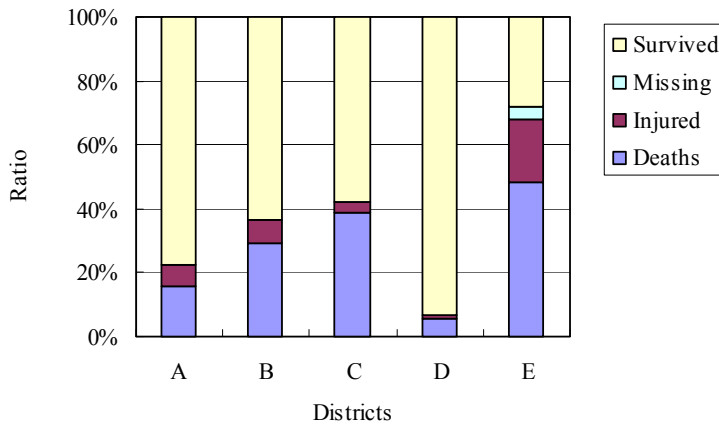
Figure 18. Statistics of damage to surveyed families

According to the answers of surveyed people, all the deaths were caused by fallen debris of houses that collapsed during the earthquake. In the survey of this investigation, the injured were fewer than the deaths, 40% were deaths and 20% were injured according to the average of all the answers. Results of the questionnaire survey in surveyed districts are compared with those in the same districts in damage statistics as shown in Figure 18. In district A of Baravat, the death ratio exceeded that of actual statistics while in other districts the death ratios are almost similar to the statistics results. Thus, our survey reflects the damage situation well though 6-7 questionnaires were applied in each district. On the other hand, our questionnaire survey had several times more injured people than the statistics. Therefore, we are now investigating what kind of standards of statistics are the most suitable to use. However, we can suggest that our results include minor injuries and thus more injuries were reported than the governmental statistics. Because, our questionnaire did not define several conditions for injuries such as whether conditions, treatment received from medical institutions, period of hospitalization or the levels of injuries, but just asked "Is there any family member who was injured?". Moreover, districts A and D had higher or similar ratio of injures than the death ratio. These two districts have characteristically more masonry structures without concrete columns than other districts. We can say that the collapse of adobe masonry structures caused more deaths and the brick masonry structures caused many injures as well as the deaths.

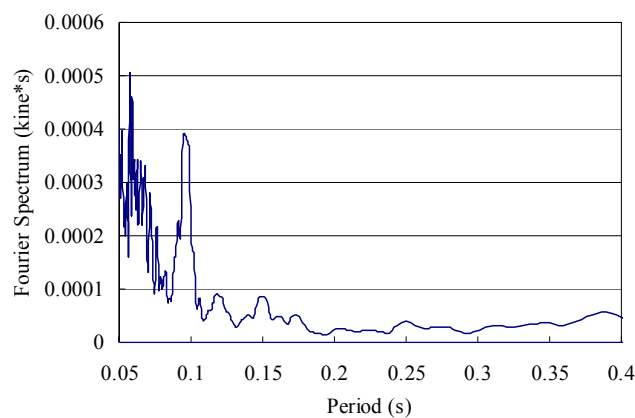
Figure 22. Survey of adobe masonry structure

Now unit weight of the elements and material characteristics for spring are listed in Table 3. The Mohr Coulomb failure model is used for the spring failure by shearing force. In the model, predominant period obtained by free vibration, was 0.13 seconds. This result corresponds nearly to the natural period of 0.1 seconds for adobe masonry structures obtained by microtremor [12] as shown in Figure 22. Therefore, this analytical model is appropriate.

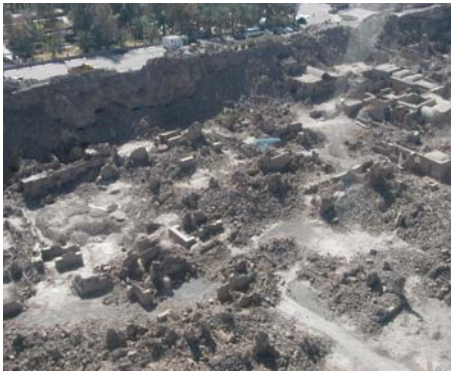
Figure 27. Collapse situation in Arg-e Bam collapse

Figure 27 is a photo of Arg-e Bam taken from the helicopter. What can be seen from a post-earthquake inspection of the adobe masonry structures built inside the rampart of this castle are only several walls and piles of adobe bricks or sand mound. Failure mode in the analysis reproduces similar collapse condition with columns of small adobe bricks in the stricken area. The analysis of this example shows that collapse situation may differ if input parameters, the model and the ground motion change. By the way, in any case, it is obvious that adobe masonry structures turns fragile once it is cracked somewhere and turns strong when is monolithic.

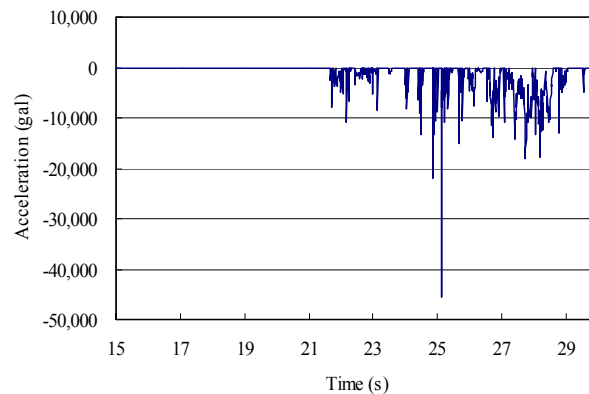
Figure 28. The acceleration affected the indoors causing brick

Figure 28 shows the vertical force that affects elements at top of the arch when collapse occurs, such as the collapse of case 1 in which no adjustment of the amplitude is considered. As soon as cracks occur in the arch, the element of the arch has as strong shock as maximum 45g at the floor. Another report [14] says that human breast becomes a few chance of severe injure by more than 45g acceleration, and more chance by more than 60g. As shown in certain models, failure depends on the thickness of the arch section, and acceleration more than 60g may cause serious impact to human lives. These shocks attacking human body are very dangerous.
